## **Appendix D**

### **Site Inspection Forms, Radiological Survey Information, and Photographs of Operable Units 2-13 and 2-14 Sites (2002)**

Appendix D contains site inspection forms, radiological survey information, and color photographs of the 15 Comprehensive Environmental Response, Compensation, and Liability Act sites at Operable Units 2-13 and 2-14 in Waste Area Group 2. These photographs were taken during the most recent institutional control inspection in June 2002, and they depict the current physical condition of each site in Operable Units 2-13 and 2-14.

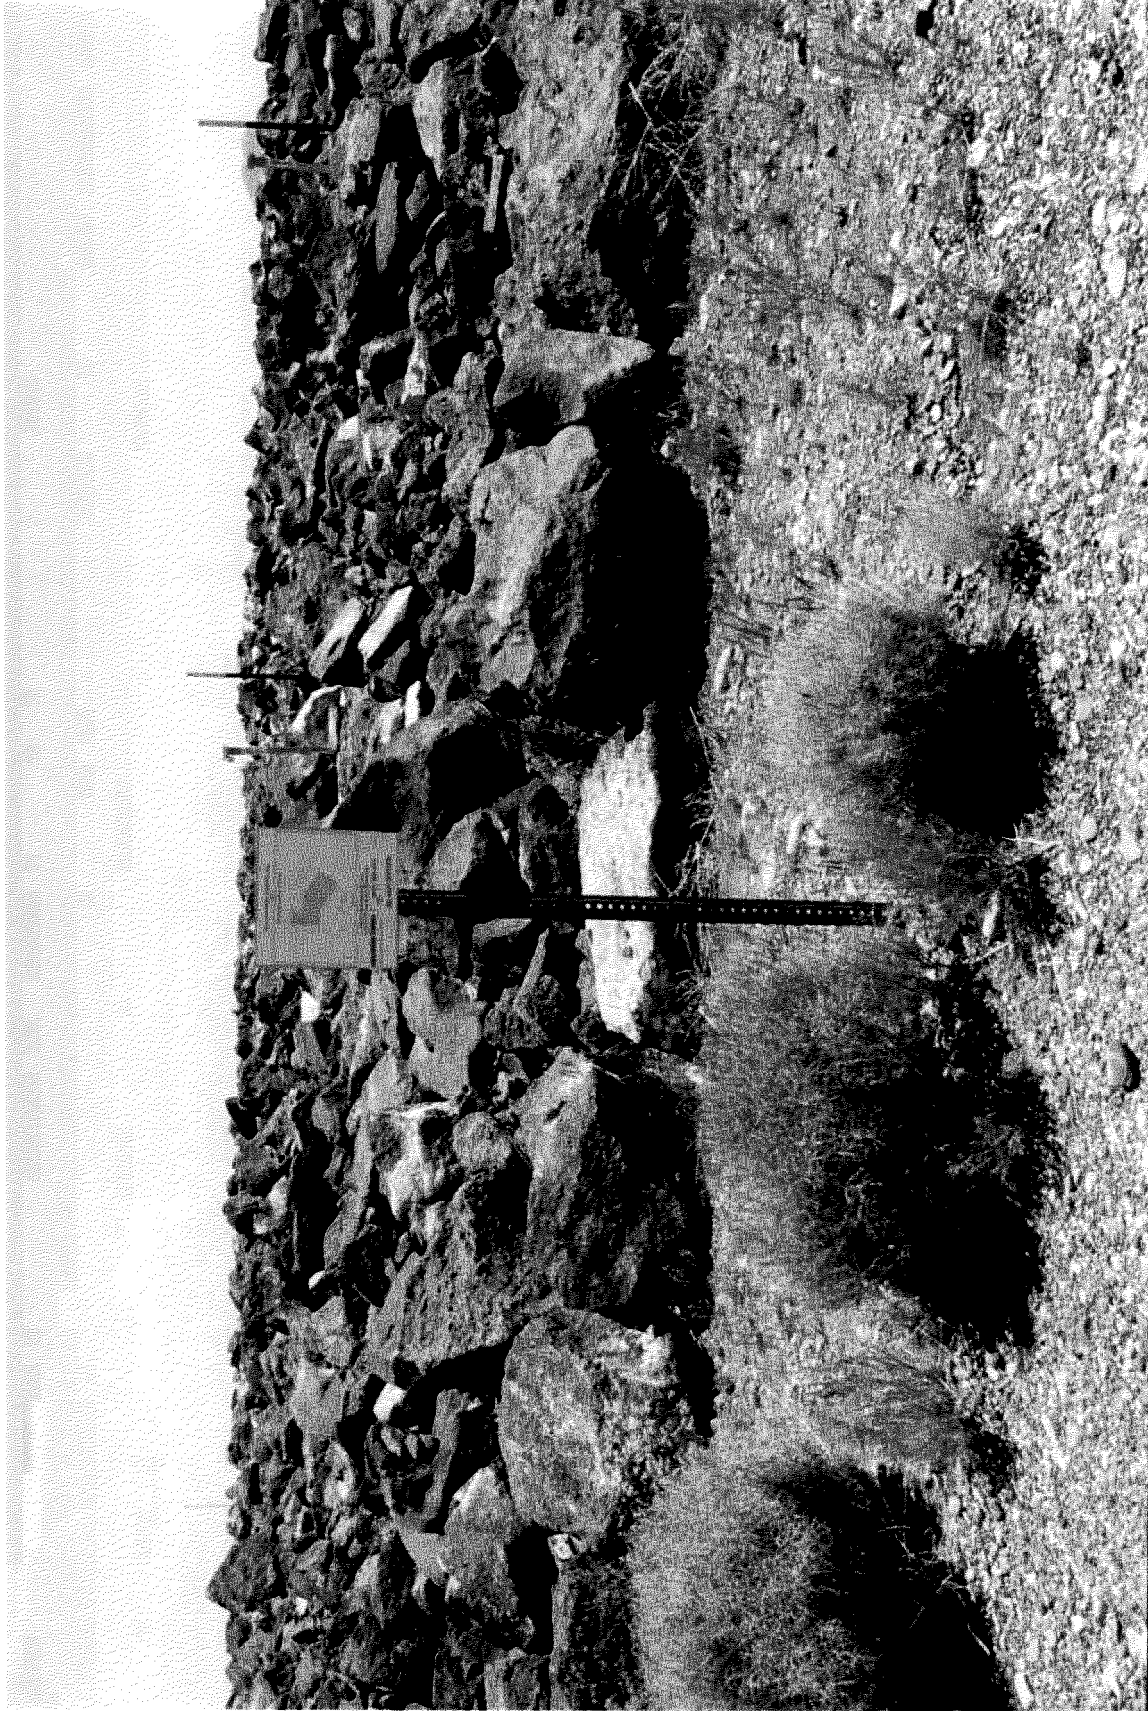
Figure D-1. The TRA-03 Warm Waste Pond cover looking east (PN02274-1)

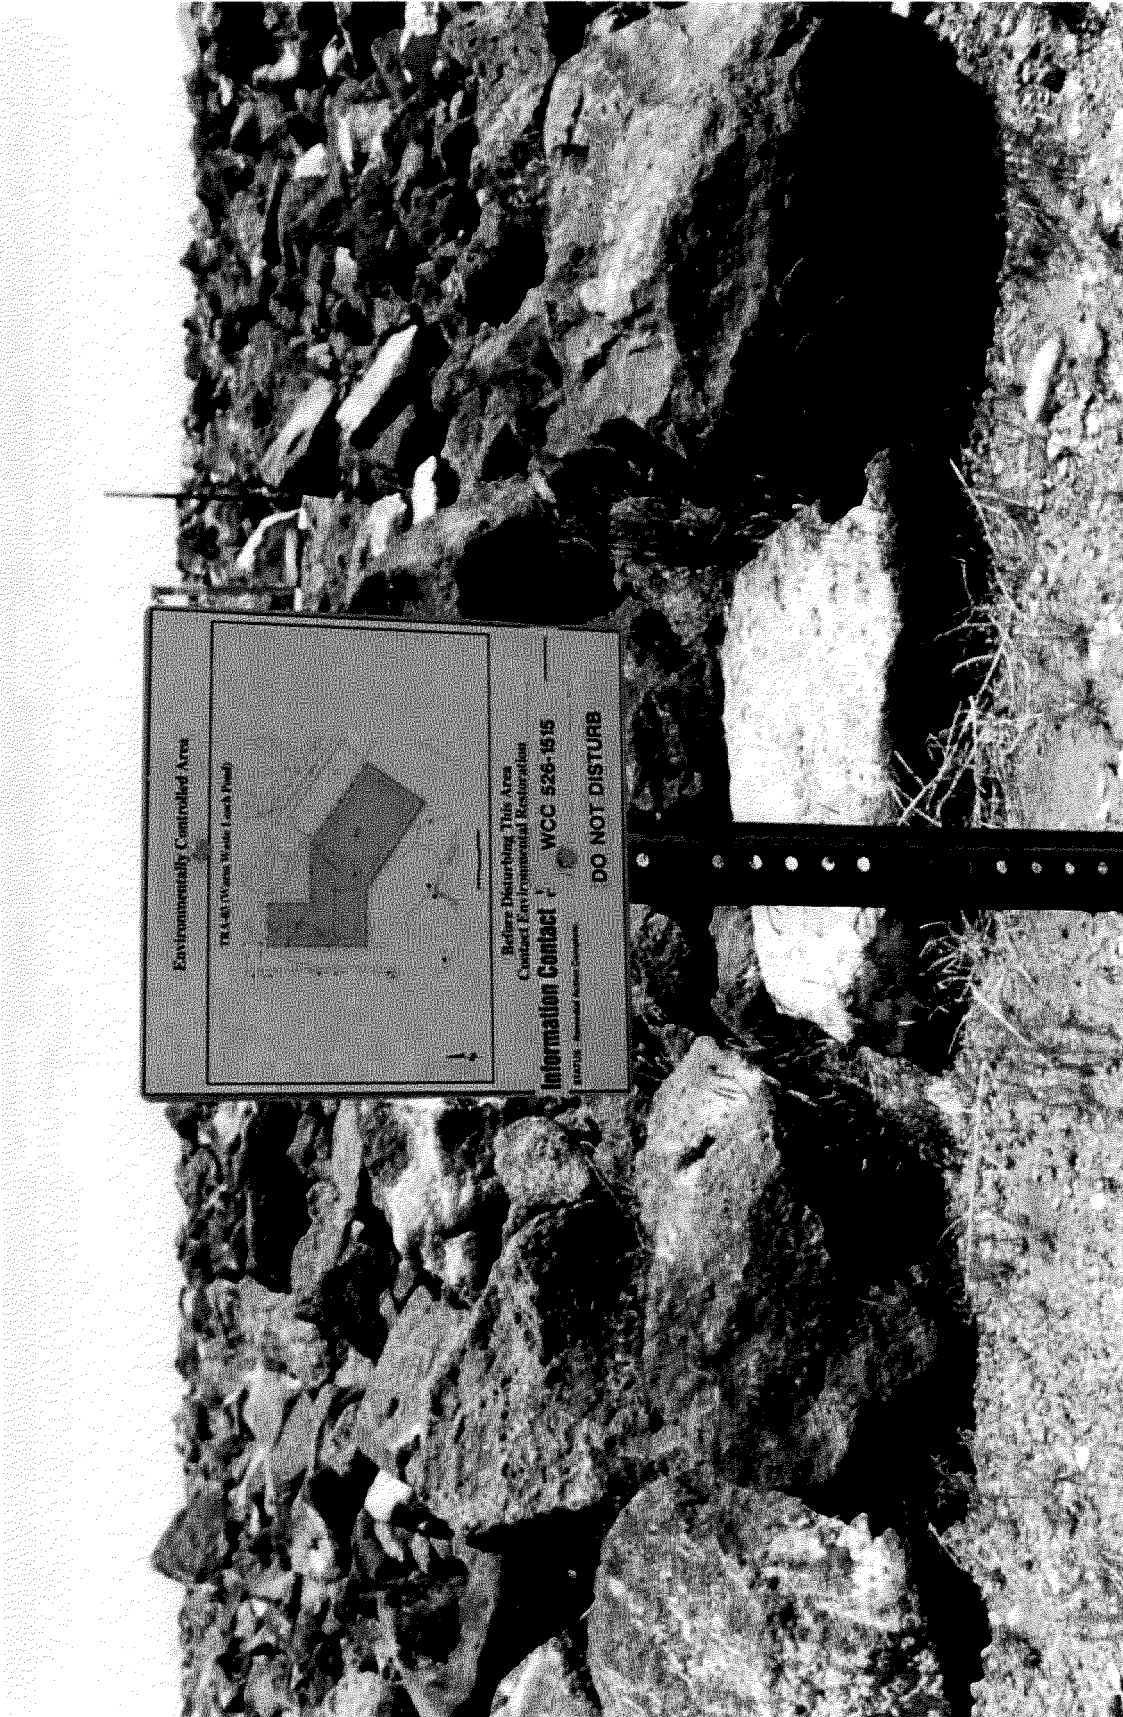
Figure D-2. Comprehensive Environmental Response, Compensation, and Liability Act sign at TRA-03 Warm Waste Pond cover (PN02274-1-15).

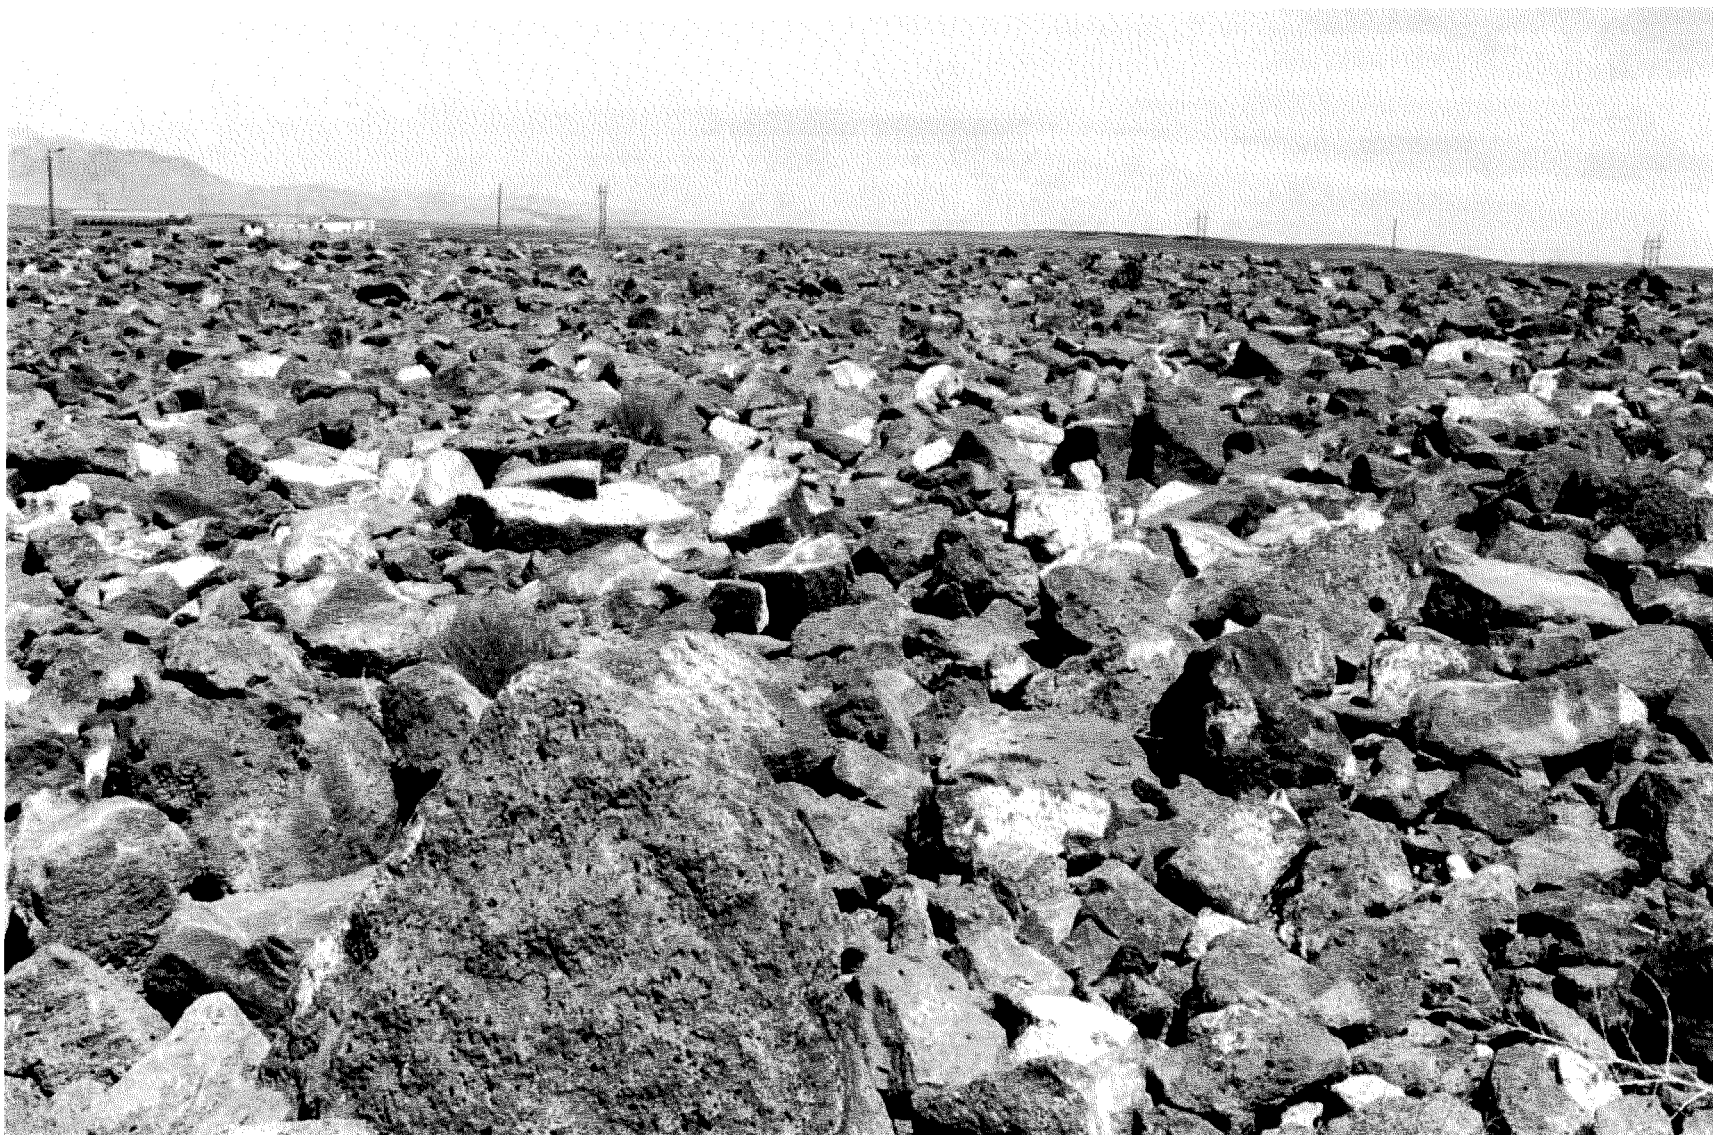
Figure D-3. Rabbitbrush growing on western portion of TRA-03 Warm Waste Pond cover (PN02274-1-16).

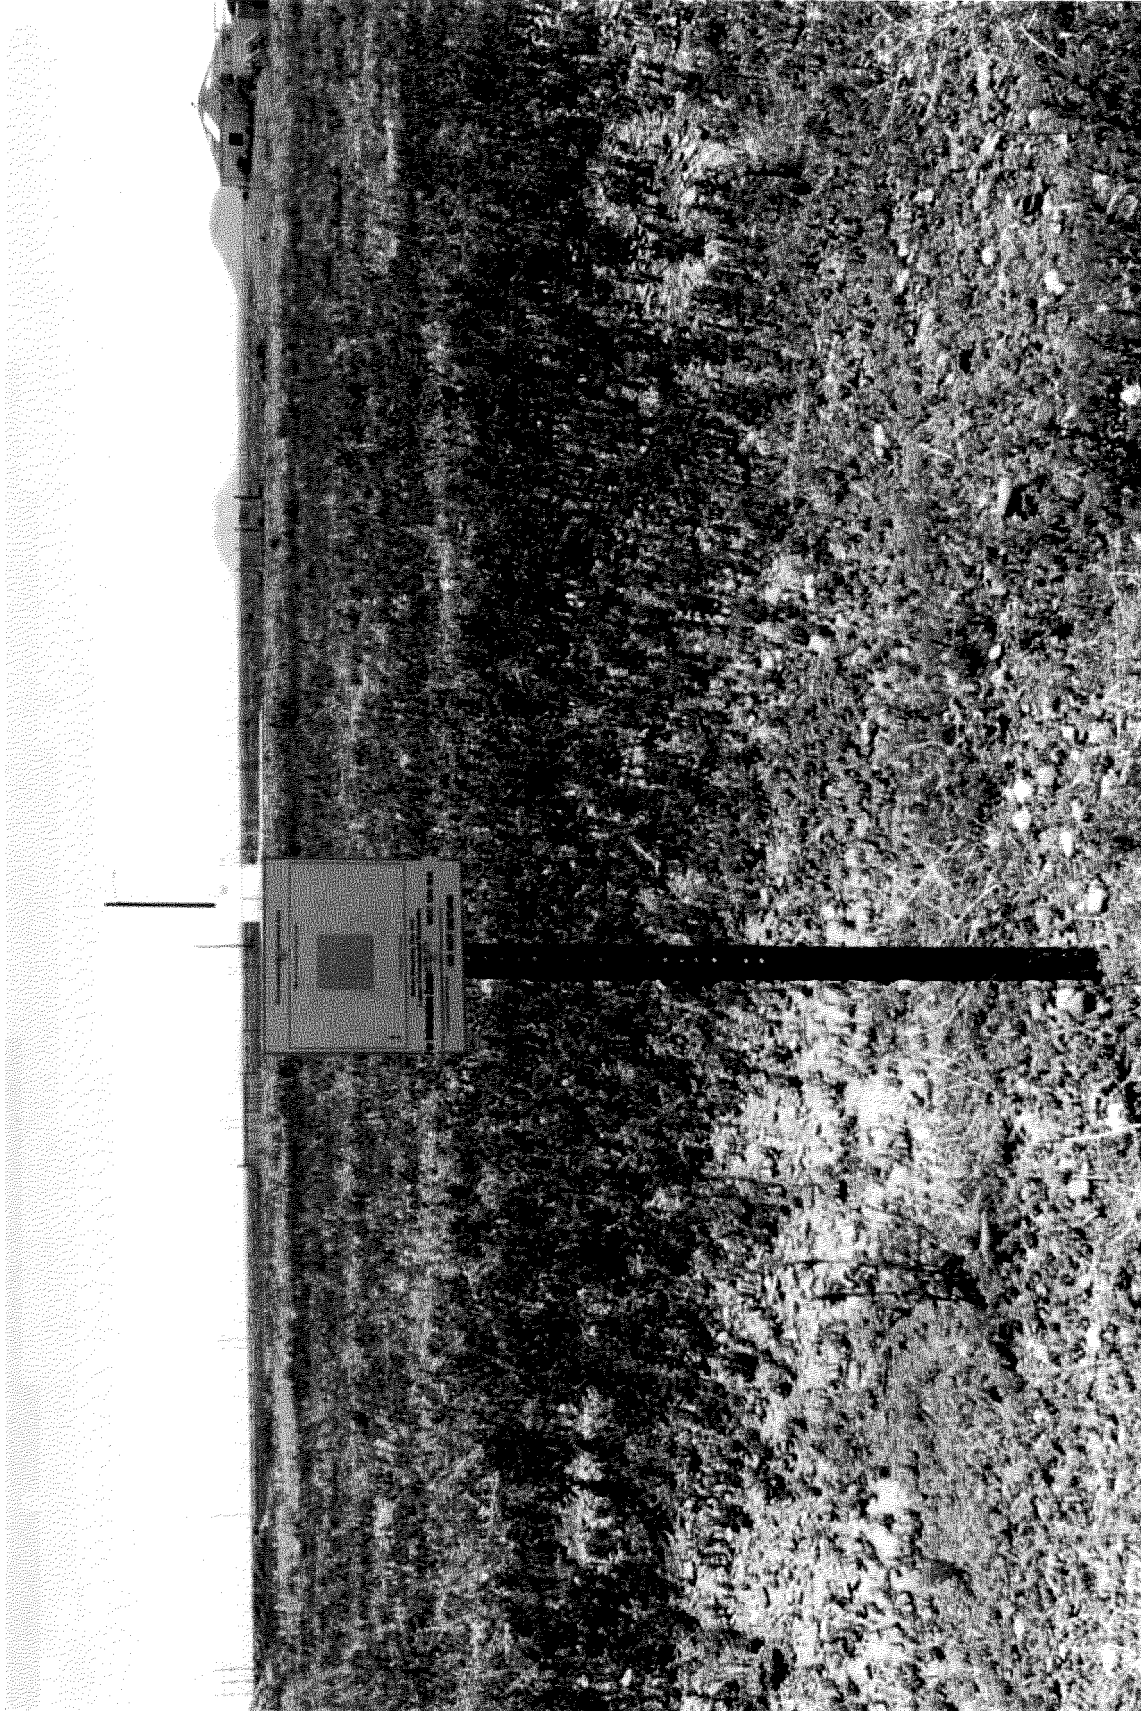
Figure D-4. West side of TRA-06 Chemical Waste Pond looking east (PN02274-1-6).

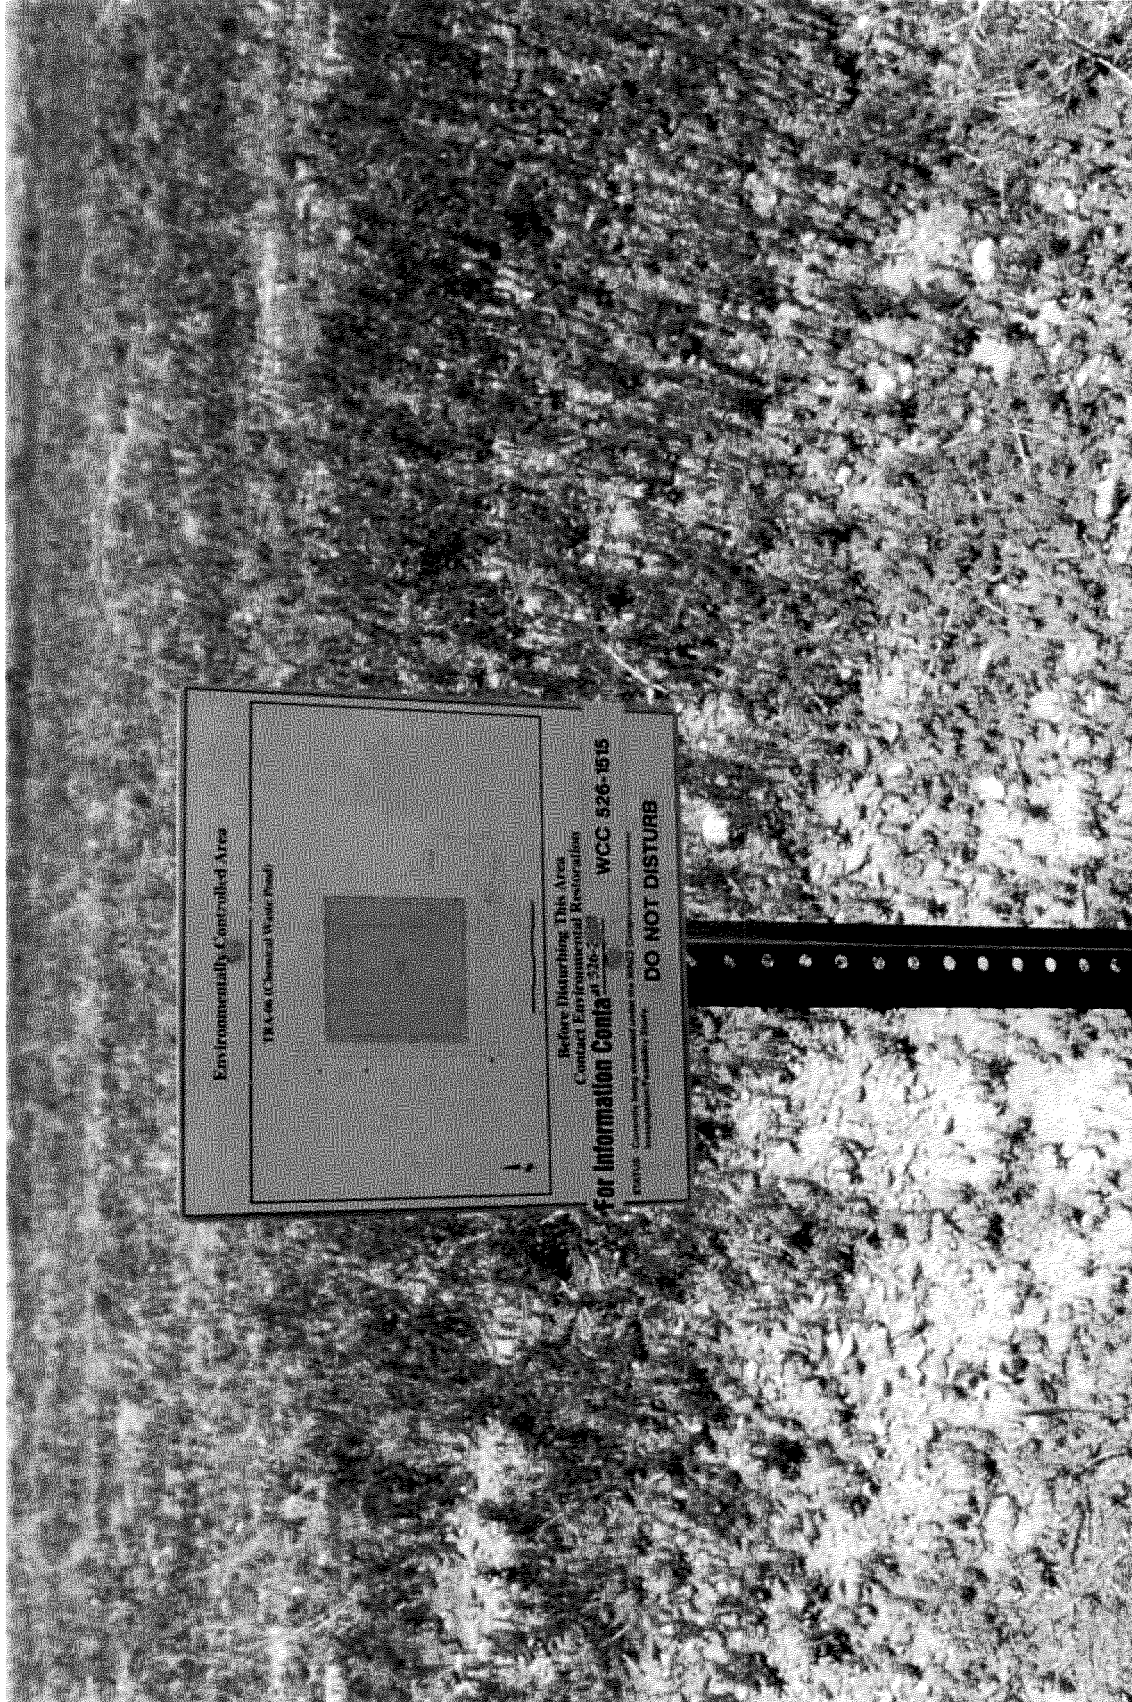
Figure D-5. Comprehensive Environmental Response, Compensation, and Liability Act sign at TRA-06 Chemical Leach Pond cover (PN02274-1-7).

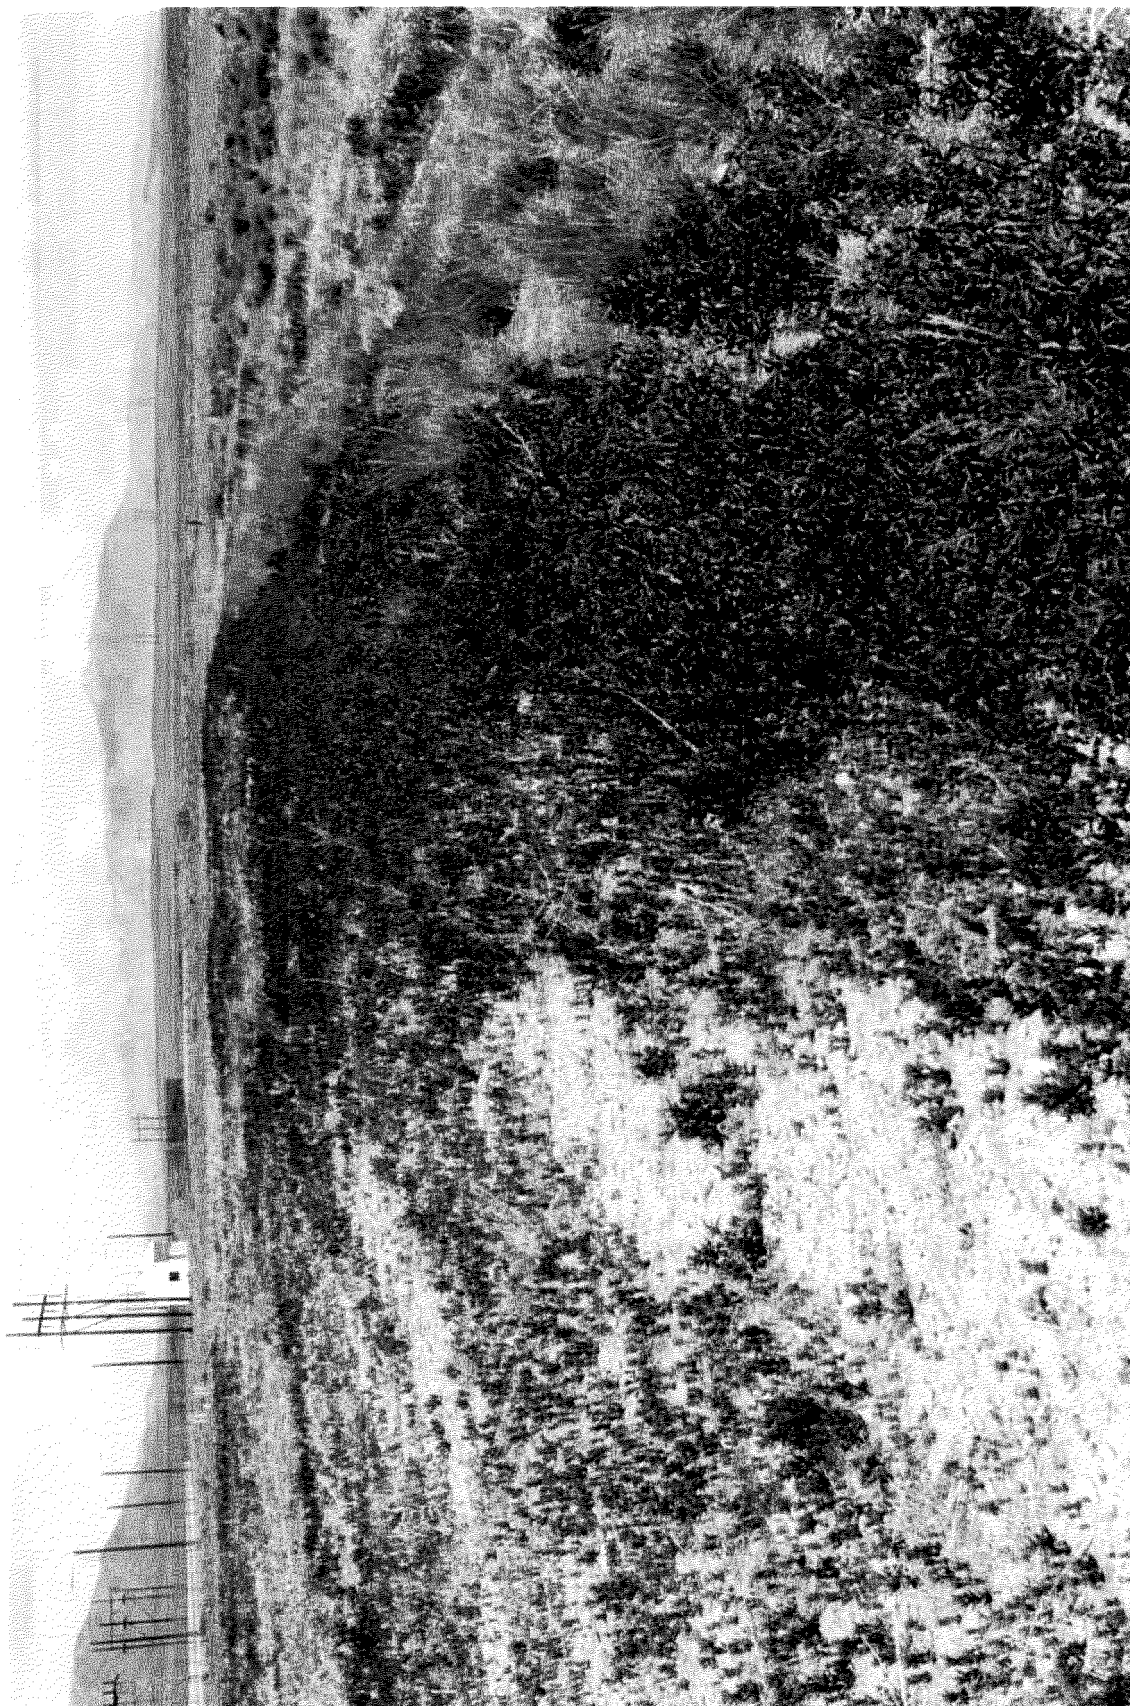
Figure D-6. View of TRA-06 Chemical Leach Pond cover looking north (PN02274-1-8).
